## Security of Supply in Curaçao's Electricity System

Report on Trip Events in February 2020

Aqualectra

Digsilent GmbH, May 2020

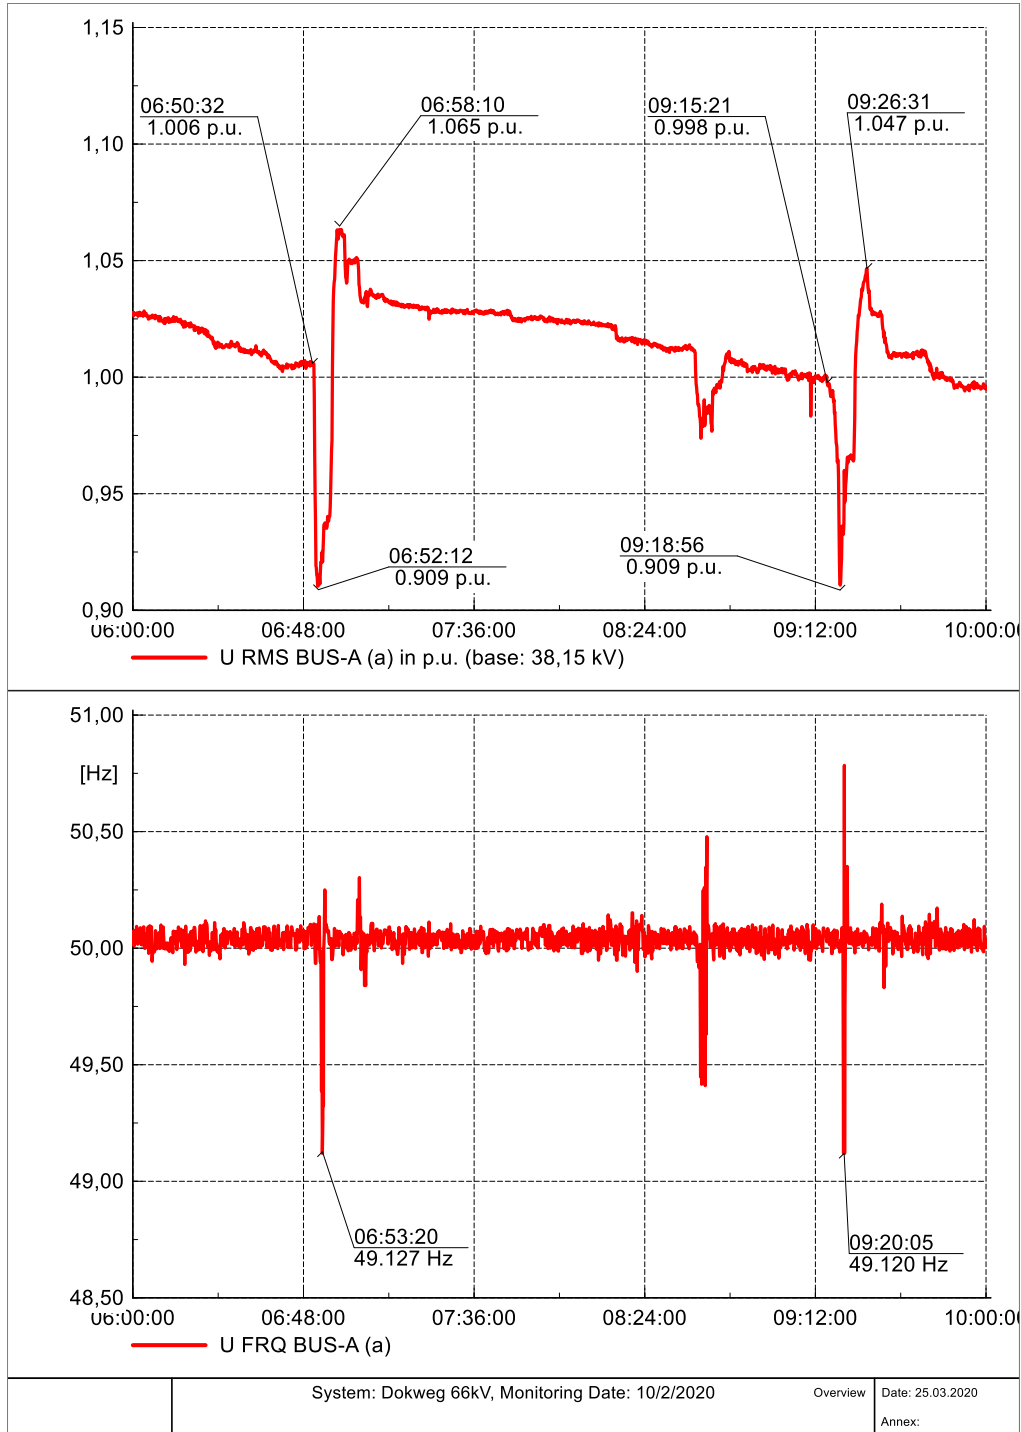
Figure 3-1: Overview of events on the 10<sup>th</sup> of February 2020 – Dokweg 66 kV – Voltage (up) and frequency (bottom)

As shown in Figure 3-1, voltage and frequency drop significantly (voltage drops down to ~0,9 p.u.) twice in a time frame of four hours.

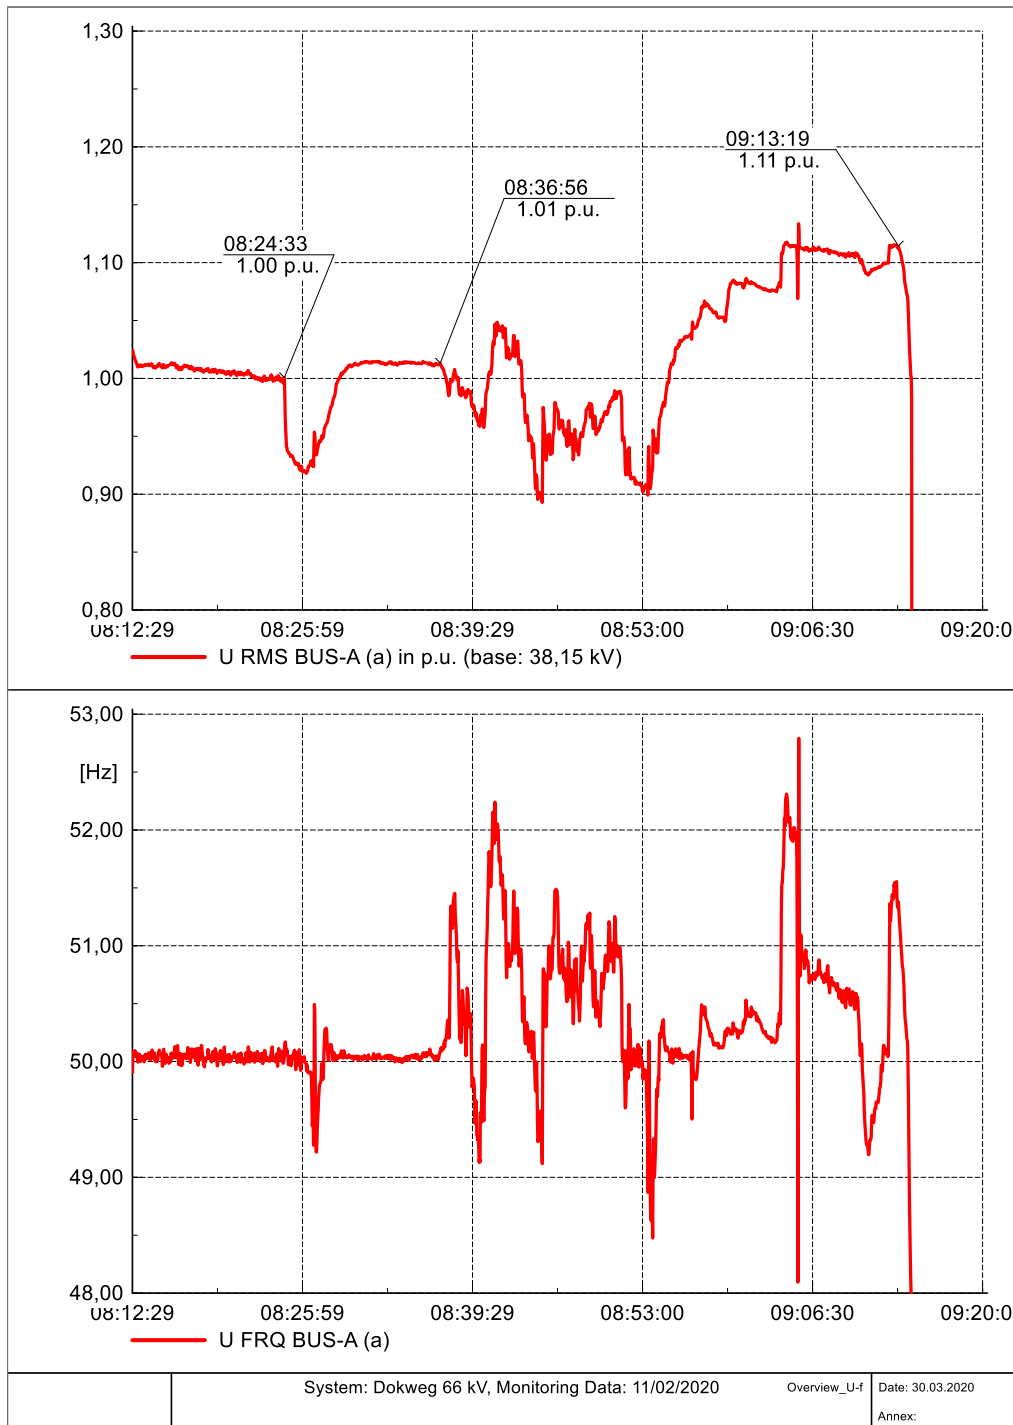
Figure 4-1: Overview of events on the 11<sup>th</sup> of February 2020 – Dokweg 66 kV – Voltage (up) and frequency (bottom)

As shown in Figure 4-1, a drop in voltage occurs at approximately 08:24 hours. After 08:36 hours, system starts to show instabilities in both voltage and frequency, and eventually system collapses (09:13 hours)

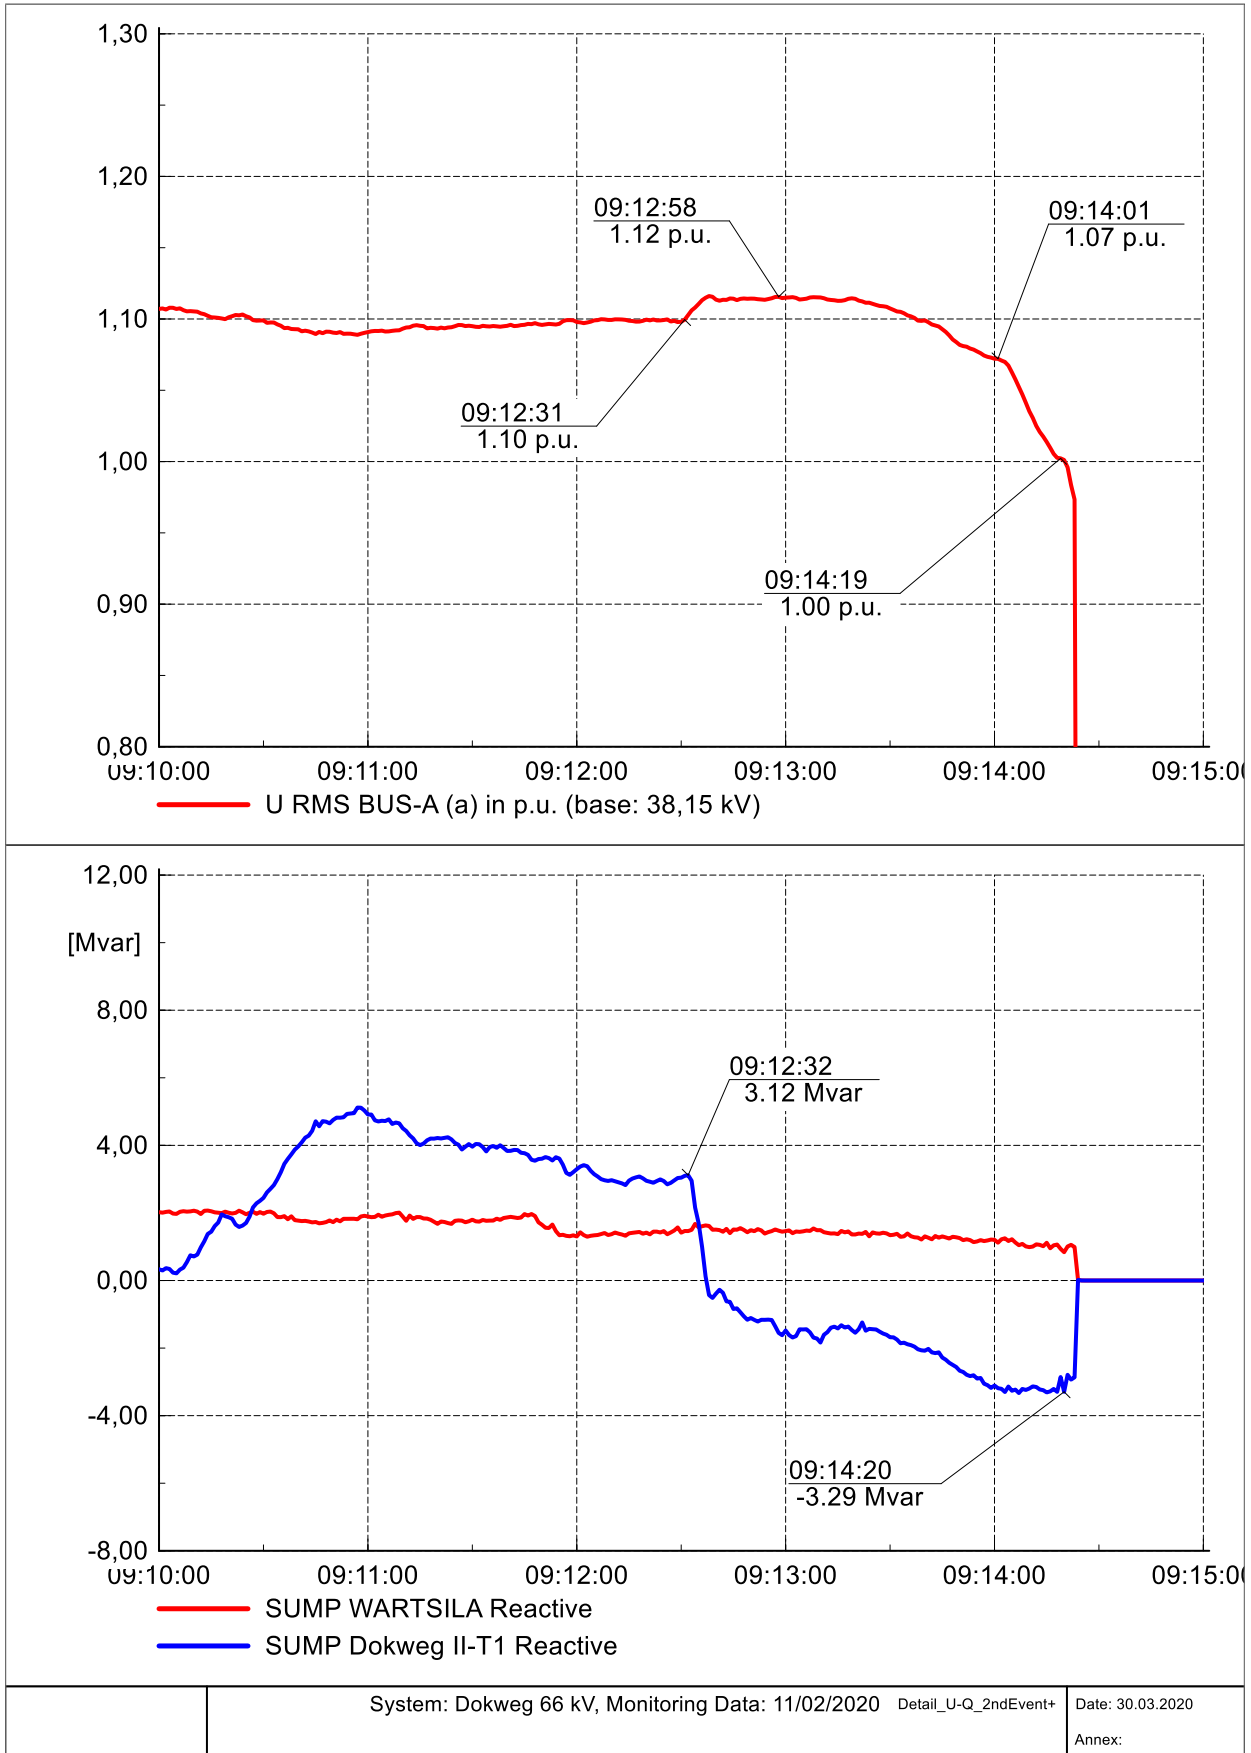
Figure 4-11: 2<sup>nd</sup> event on the 11<sup>th</sup> of February 2020 – PFM Dokweg 66 kV – Voltage (up) and reactive power (bottom)

- 
- a. In overvoltage conditions, generators in Dokweg II-T1 increase the reactive power production, when it is exactly the opposite what would have been expected (see Figure 4-11 at 09:10 hours)
  - b. Frequency regulation of generators in WARTSILA show a delay in the response which causes that, in case of fast frequency variations, the actual response is counter-productive: increase of output power when frequency increases and vice versa (see Figure 4-12).
  - c. Generators in Dokweg II-T1 increase their output power even when frequency is above nominal (see Figure 4-12 at 09:13 hours).
