## POWER FAILURE INVESTIGATION

# Investigation of the blackout incident Curaçao on 27 August 2025

Aqualectra

Report No.: 25-2939, Rev. 0

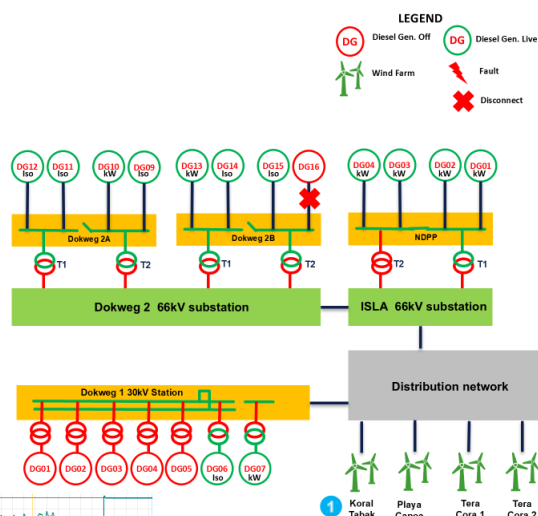
**Figure 3-3 Event 1 – significant wind energy drops due to wind fluctuation**

- In 13 min the wind energy dropped by **22.4 MW (54%)**
- Spinning reserve: 20.6 MW
- Cold reserve: 31.2 MW

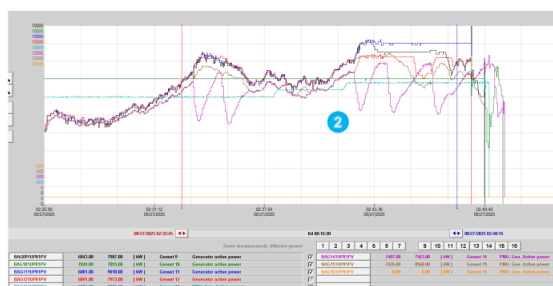
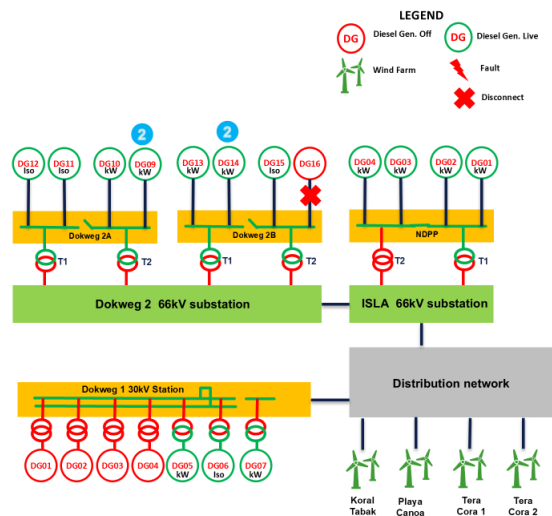
**Figure 3-4 Event 2 and 3 with time stamps and an explanation of the events**

- DG05 Online and changed to Iso-mode and at 02:45:03 back to kW mode.

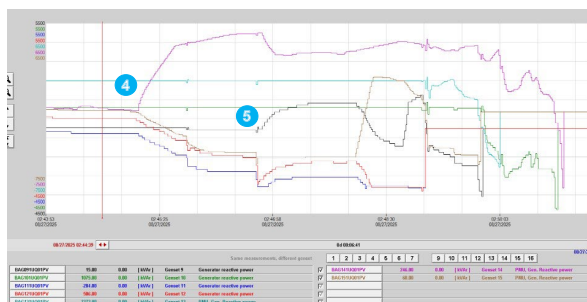
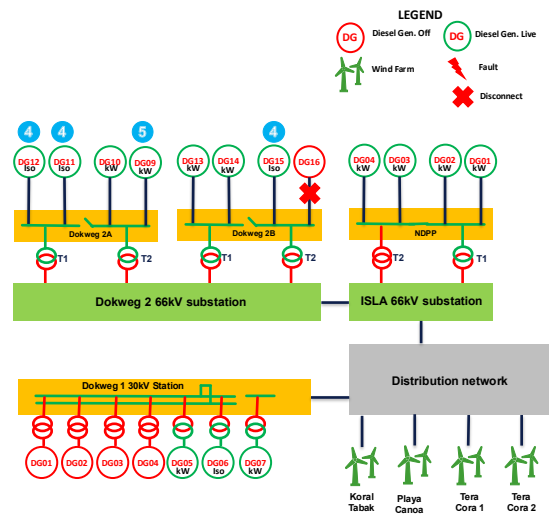
**Figure 3-5 Events 4 and 5 – increased reactive power absorption by DG11, DG12 and DG15 and a change of DG9 operating mode.**

- 4 Event: Absolute time: 02:45:06
  - Due to DG14 Major increase reactive power output. DG11/12/15 increased reactive power absorption
- 5 Event: Absolute time: 02:46:47
  - The operator manually switched DG9 from power factor to voltage droop, The resulted in increasing reactive power output of DG9. DG11/12/15 further increased reactive power absorption

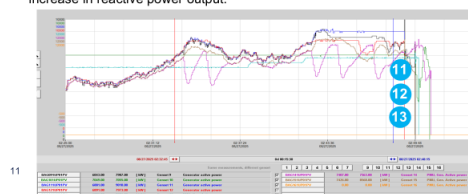
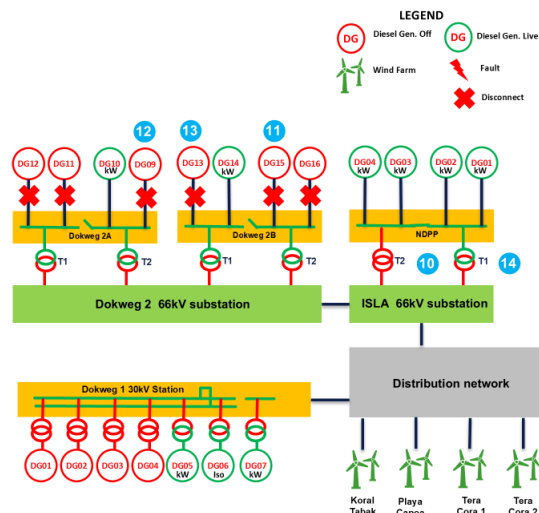
**Figure 3-7 Events 10 to 14. NDPP Transformers automatic voltage control and tripping of DG9, DG13 and DG15 by under-excitation protection systems to trip**

At 02:49:45 a major disruption in reactive power balance caused a sharp rise in the 66 kV grid voltage. The NDPP units, operating in voltage-droop mode, detected this increase at their 11 kV terminals and began absorbing reactive power. However, their terminal voltage was influenced not only by the units' automatic voltage regulators but also by the automatic voltage controller on the NDPP 66/11 kV transformer. This transformer controller reacted approximately 40 seconds later, reducing the terminal voltage and triggering a sudden surge in reactive power output from the NDPP units.

- 10 Event: Absolute time: 02:49:45
  - NDPP Step-up Transformer automatic voltage control activated. As a result NDPP units major increase in reactive power output.
- 11 Event: Absolute time: 02:49:47
  - DG15 tripped on underexcitation
- 12 Event: Absolute time: 02:49:48
  - DG9 tripped on underexcitation
- 13 Event: Absolute time: 02:50:02
  - DG13 tripped on underexcitation
- 14 Event: Absolute time: 02:50:47
  - NDPP Step-up Transformer automatic voltage control activated. As a result NDPP units major increase in reactive power output.

- Operate the 66 kV OLTCs at NDPP in manual mode in manual mode and ensure all tap changes are coordinated with power plant operators.
- Specifically for Nijlweg-Weis to investigate the conditions automatic voltage control by performing system studies.

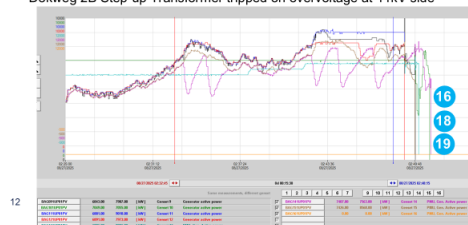
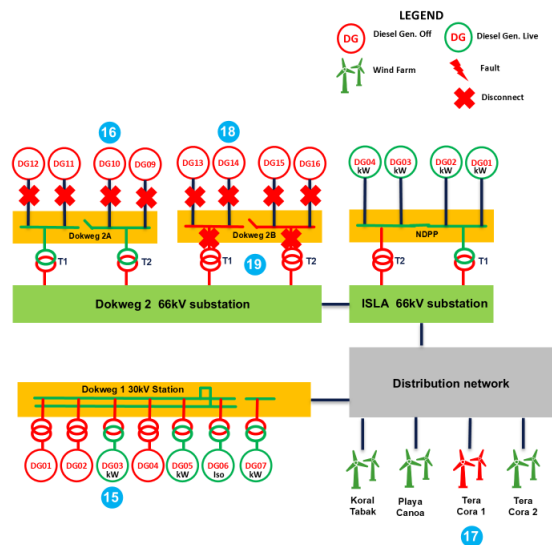
Figure 3-8 Events 16 to 19 – Tripping of DG10, DG14 and windfarm TC1

- 15 Event: Absolute time: 02:50:48
  - DG3 online
- 16 Event: Absolute time: 02:50:49
  - DG10 tripped on underexcitation
- 17 Event: Absolute time: 02:50:50
  - Wind farm TC1 disconnected
- 18 Event: Absolute time: 02:50:54
  - DG14 tripped on underexcitation
- 19 Event: Absolute time: 02:50:58
  - Dokweg 2B Step-up Transformer tripped on overvoltage at 11kV side

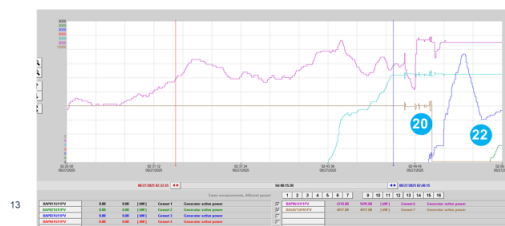
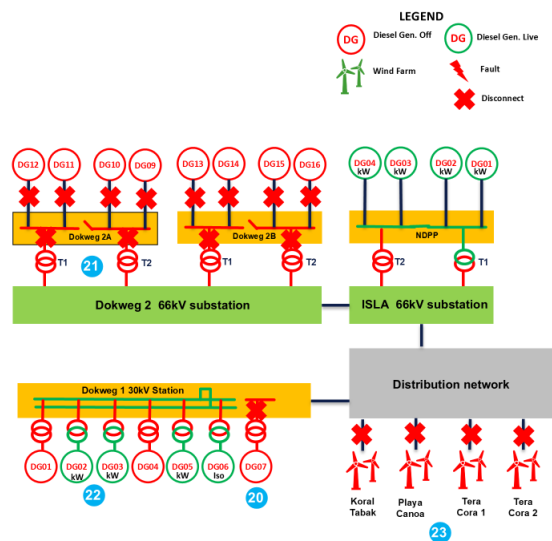
Figure 3-9 Events 20 to 23 – Tripping of DG7 and all remaining windfarms (TC2, PC and KT)

- 20 Event: Absolute time: 02:50:59
  - DG7 tripped on underexcitation
- 21 Event: Absolute time: 02:50:59
  - Dokweg 2A Step-up Transformer tripped on under frequency at 11kV side
- 22 Event: Absolute time: 02:55:07
  - DG2 online and DG3 switched to Iso-mode and back to kW mode
- 23 Event: Absolute time: 02:56:04
  - Wind farm TC2, PC and KT disconnected

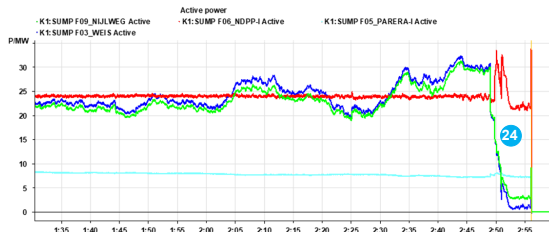
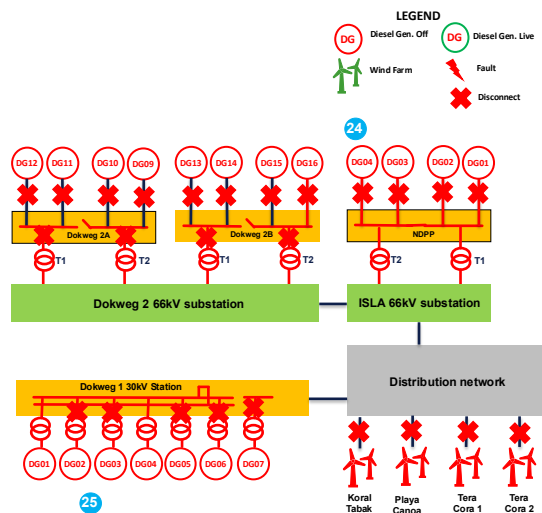
Figure 3-10 Events 24 and 25 – tripping of last remaining generation resulting in a full system blackout

- DG2, DG3, DG5 and DG6 from Dokweg 1 tripped on underexcitation

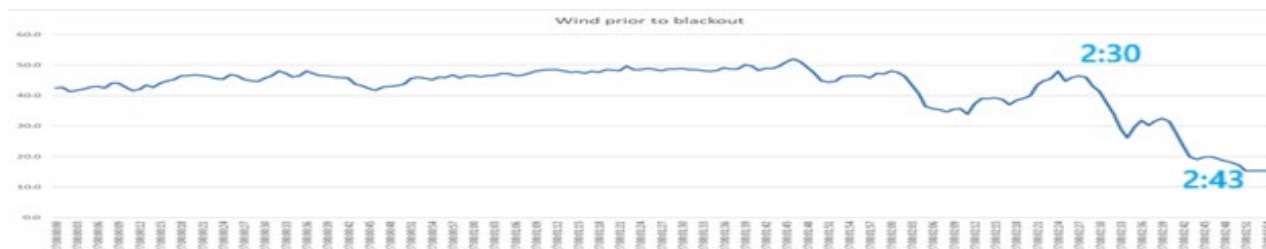
Figure 3-11 Active power wind farms 27-08-2025 from 0:00 until blackout at 02:56

The active and reactive power in the system were relatively stable until the power from the wind farms dropped at 2:30 from 46 MW down to 20 MW at 2:43, see Figure 3-11.

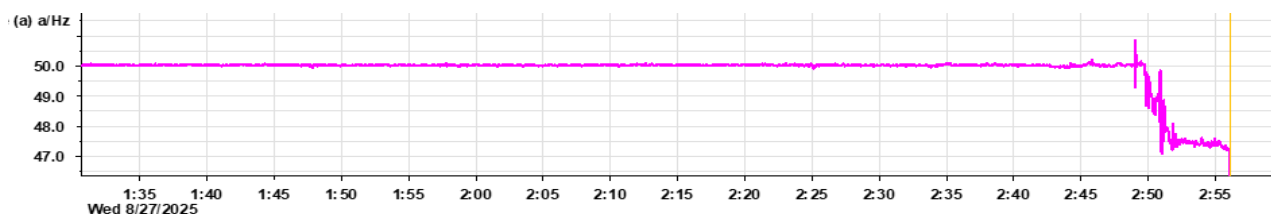
**Figure 3-13 Grid frequency**

Although the units of Dokweg 2A/2B were operating near maximum output, the frequency was maintained without load shedding, see Figure 3-13, until units DG 11, 12 tripped at 2:49 because of too high absorption of reactive power.

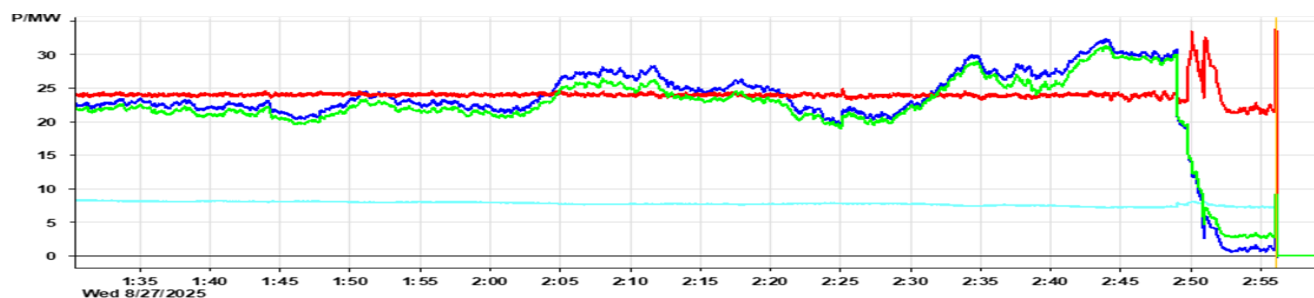
**Figure 3-14 Active power NDPP and net demand Nijlweg-Weis (gross demand-generation DKW 1/ wind farms)** RED: NDPP-I (NDPPII offline); Green: Nijlweg feeder; Blue: Weis feeder

Massive load shedding in load center Nijlweg-Weis, starting at 2:49, and power surges of the NDPP units at 2:50, see Figure 3-14, helped the power system to survive, however the frequency could not be maintained and dropped to 47.5 Hz, see Figure 3-13. When the remaining 3 wind farms tripped at 2:56 (wind farm Tera Cora 1 tripped already at 2:51), all remaining diesel generating units tripped and the system blacked out.

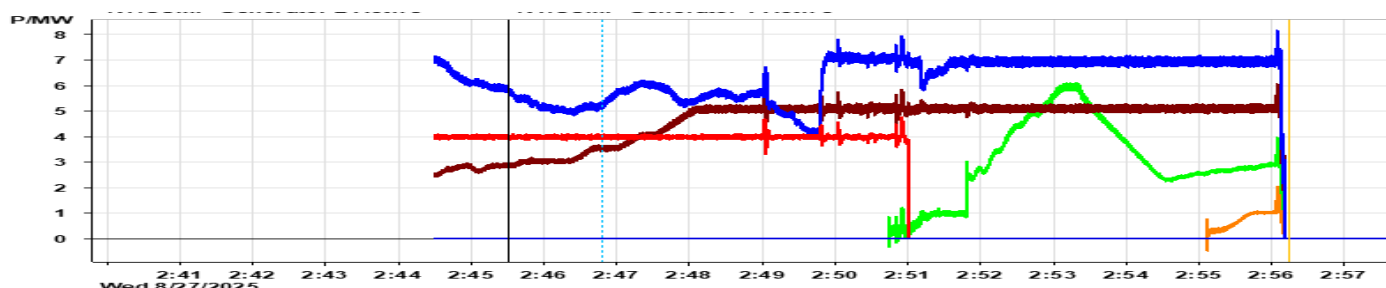
**Figure 3-15 Active power output Dokweg 1 units during the last 12 minutes before blackout**

was switched to isochronous control just before 2:51. But at 2:53 it was switched back to kW mode with deactivated frequency control. The start-up of DG 2 at 2:55 was too late to save the system

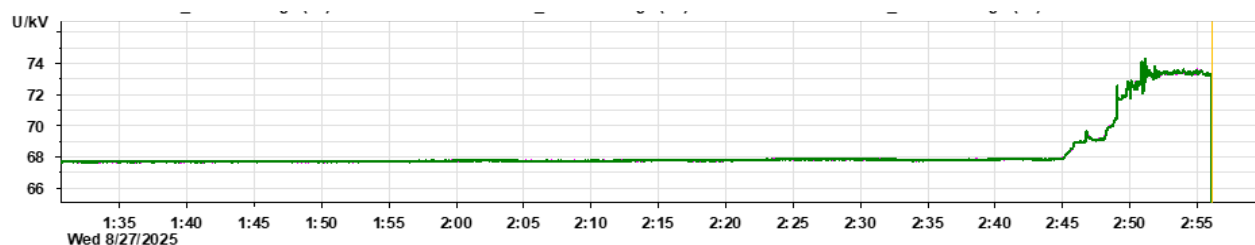
**Figure 3-18 66 kV grid voltage**

The 66 kV grid voltage increased rapidly to 74 kV after all Dokweg 2A/2B were tripped at 2:51, see Figure 3-18

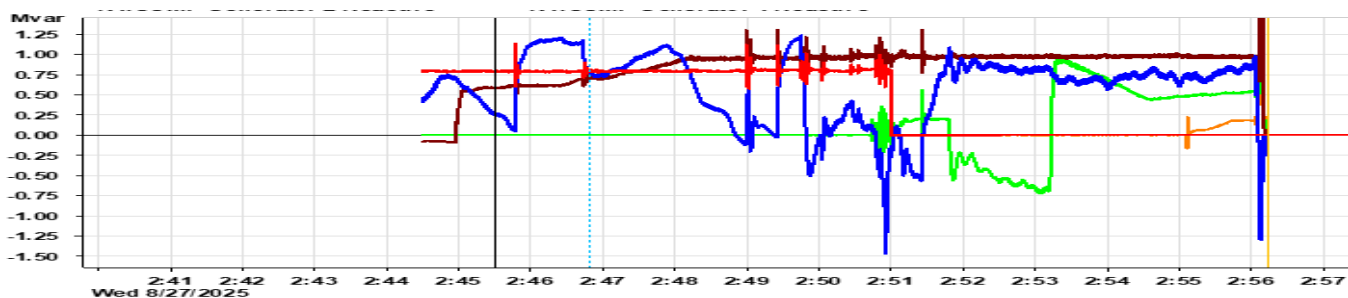
Figure 3-20 reactive power Dokweg 1 units during the last 12 minutes before blackout. Blue: DG 6, Brown: DG 5, Red: DG 7, Green DG 3, Orange: DG 2

The reactive power output of the unit in voltage control at Dokweg 1, DG 6, was interfered by the automatic voltage regulation of the Nijlweg-Weis transformers. Because of increasing 66 kV voltage also the 30 kV voltage increased and the 30 kV automatic voltage control instructed a tap change of the Nijlweg-Weis transformers between 2:45-2:46, between 2:49-2:50 and between 2:51-2:52, see Figure 3-21. This disruption by the automatic tap changing made the voltage support by the Dokweg 1 units ineffective

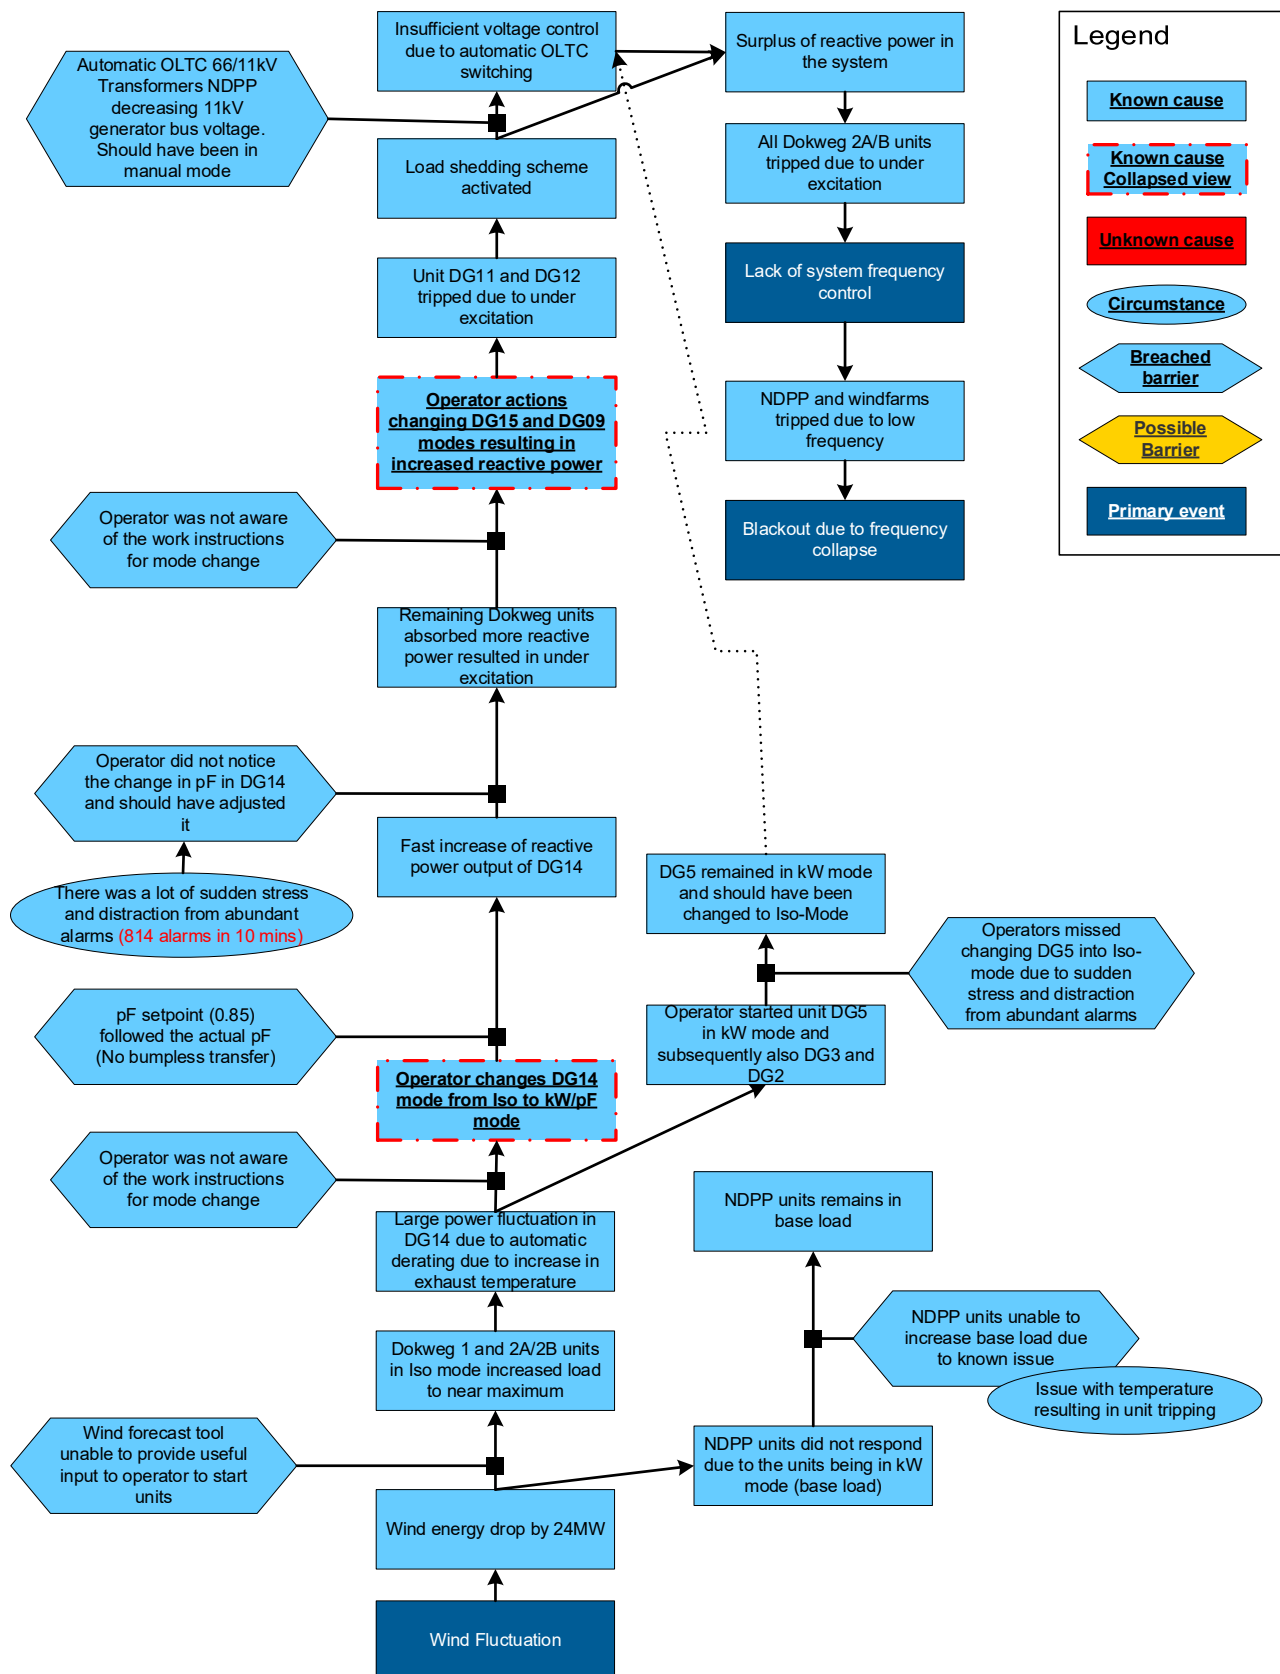
Figure 4-1 Total incident map of the blackout that occurred on 27 August 2025

NOTE: The sequence of events in the incident map evolves over time from the bottom to the top. The time scales between the various events can differ significantly. As such it is important to notice that an event placed at a higher position in the graph does not necessarily have to happen after an event placed at a lower position in case they are not connected by a causal line.

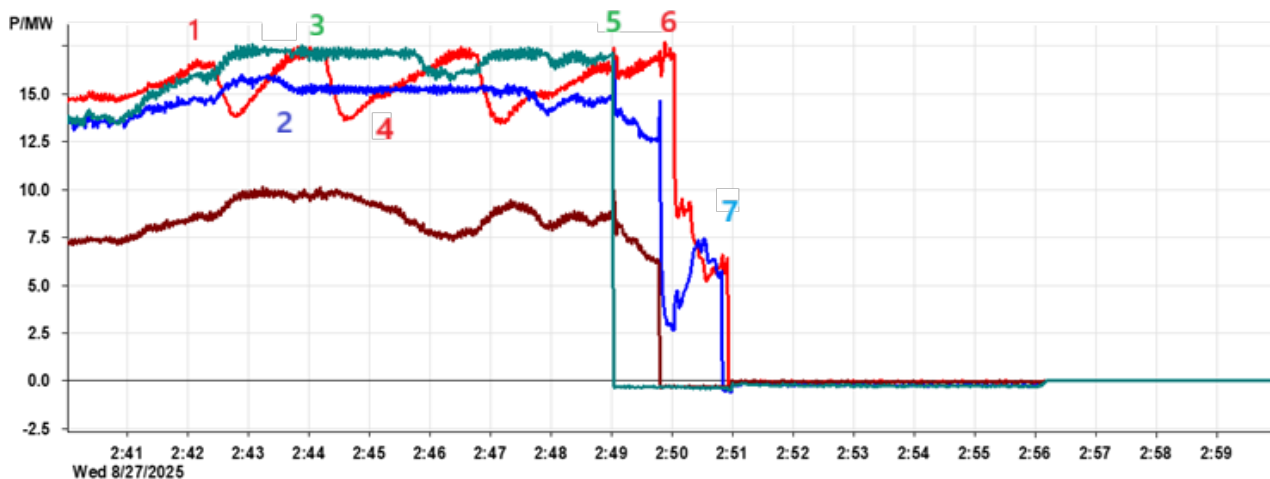
### Active power DKW 2A/2B power plants at 66 kV connection step-up transformers

- **1:** DG 13/14: oscillation output by DG 14
- **2:** at 2:43:28: DG 9 switched to kW mode manual, switched to isochronous mode at 2:46:47
- **3:** at 2:44:07: DG 11 switched to kW control manual
- At 2:44 to 2:47: DG 9/10 at 15 MW, not participating in frequency support while not at rated output
- At 2:43 to 2:46: DG 11/12 at 17.5 MW
- **4:** at 2:45:06: DG 14 switched to kW mode and switched to isochronous mode at 2:46:59 Again, switch to kW mode at 2:47:54 and to droop mode at 2:48:39. The at 2:49:16 switch to kW mode.
- **5:** at 2:49: trip of 2 units (DG 11, 12), frequency transient
- **6:** at 2:50: drop frequency after trip of 3 units (DG 15, 9, 13) to 49.0 Hz
- **7:** at 2:51 onwards: further decrease of frequency to 47.5 Hz after trip of the remaining DKW 2A and 2B units DG 10, 14. Now only 4 NDPP and 3 DKW 1 units online.

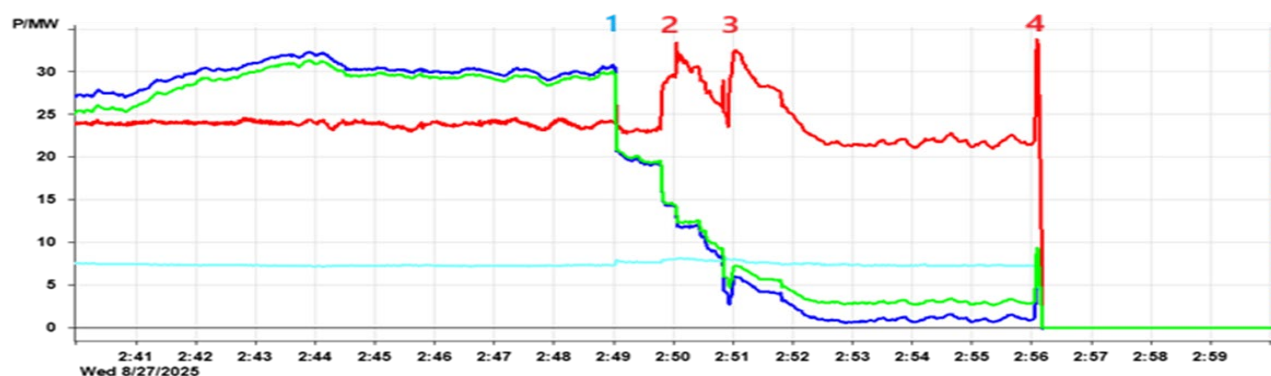
**Active power NDPP power plant and net demand load center Nijlweg-Weis at 66 kV connection transformers**  
RED: NDPP-I (NDPP-II offline); Green: Nijlweg feeder; Blue: Weis feeder

- Until 2:50 steady output of 4 units at 24 MW total.
- **1**: 2:49: load shedding Nijlweg-Weis load center when DG 11, 12 tripped
- **2**: 2:50: sudden power surge from 24 to 30 MW 45 when DG 15, 9, 13 tripped. Further load shedding
- **3**: 2:51: sudden power surge from 24 to 32 MW when DG 10, 14 tripped. Further load shedding
- 2:53: output stabilized at 22 MW until system collapsed
- **4**: 2:56 all units trip after wind farms trip

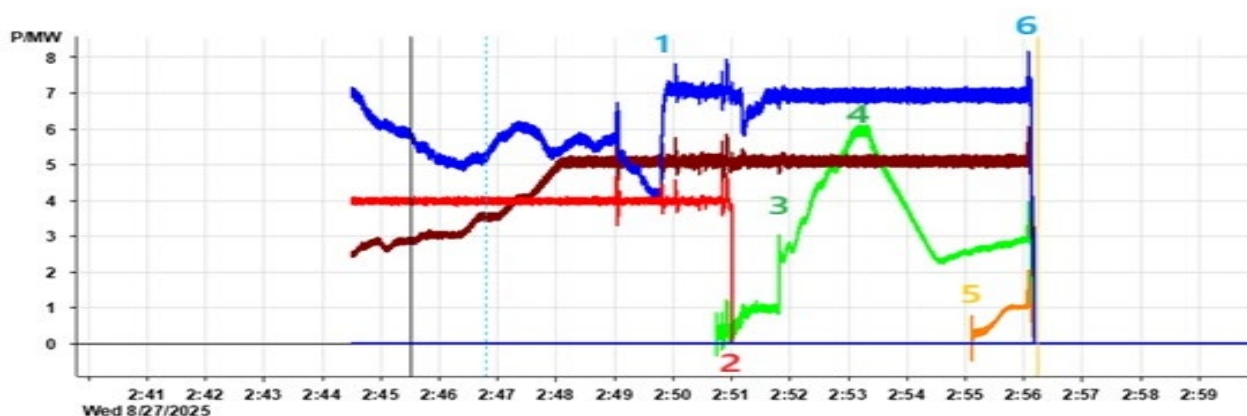
#### Active power Dokweg 1 units

- **5:** 2:55:07 DG 2 synchronised.
- **6:** 2:56 trip of all 4 DKW 1 units after wind farms trip

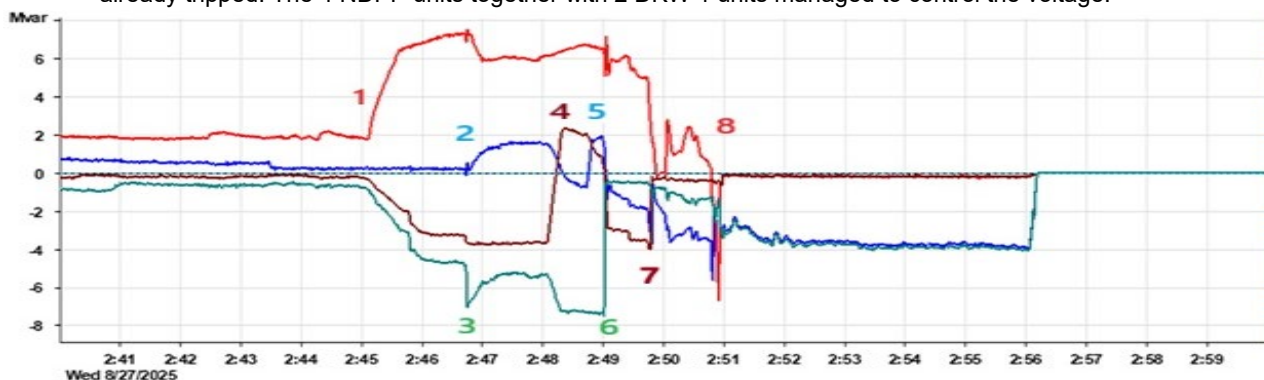
### Reactive power DKW 2A/2B power plants at 66 kV connection step-up transformers

- Voltage 66 kV: the voltage started to increase from the moment DG 14 was switched to power factor control with the high, sudden increase of reactive power injection. The voltage increased further when DG 15 switched to power factor control. A voltage jump occurred at the moment when units tripped at underexcitation and load shedding started at 2:49. Strangely enough the voltage stabilized at 73.5 kV while all DKW 2A and 2B were already tripped. The 4 NDPP units together with 2 DKW 1 units managed to control the voltage.

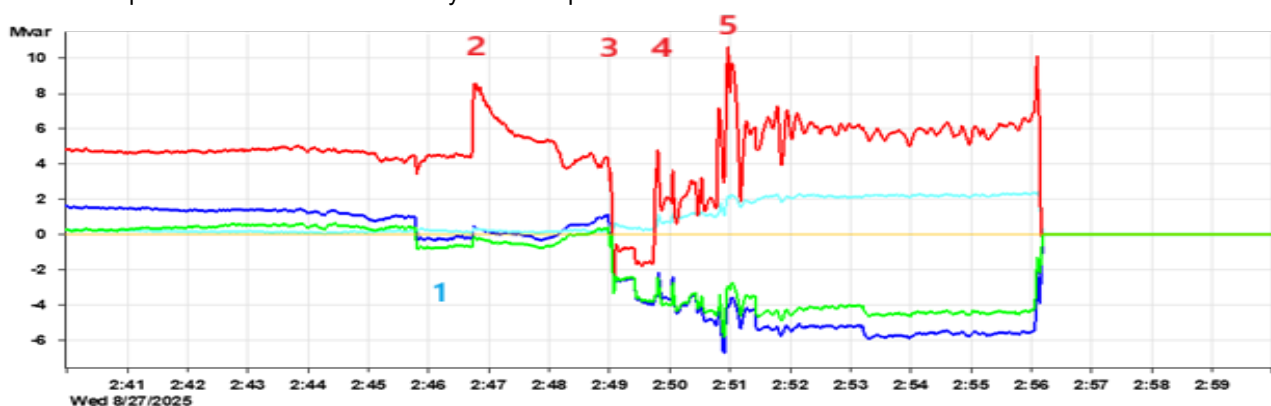
**Reactive power NDPP power plant and net demand load center Nijlweg-Weis at 66 kV connection transformers**  
RED: NDPP-I (NDPPII offline); Green: Nijlweg feeder; Blue: Weis feeder

- Until 2:47 steady output of 4 units at 5 Mvar export total.
- **1**: 2:46: reactive power reduction Nijlweg-Weis because of tap change Nijlweg-Weis transformer, which was on automatic voltage control.
- **2**: 2:47: reactive power surge NDPP units because of tap change step up transformer, which was on automatic voltage control.
- **3**: 2:49: sudden reactive power drop when 66 kV voltage increased because of trip DG 11, 12.
- **4**: 2:50: sudden reactive power increase because of tap change step up transformer.
- **5**: 2:51: sudden reactive power increase because of tap change step up transformer
- output stabilized at 22 MW until system collapsed

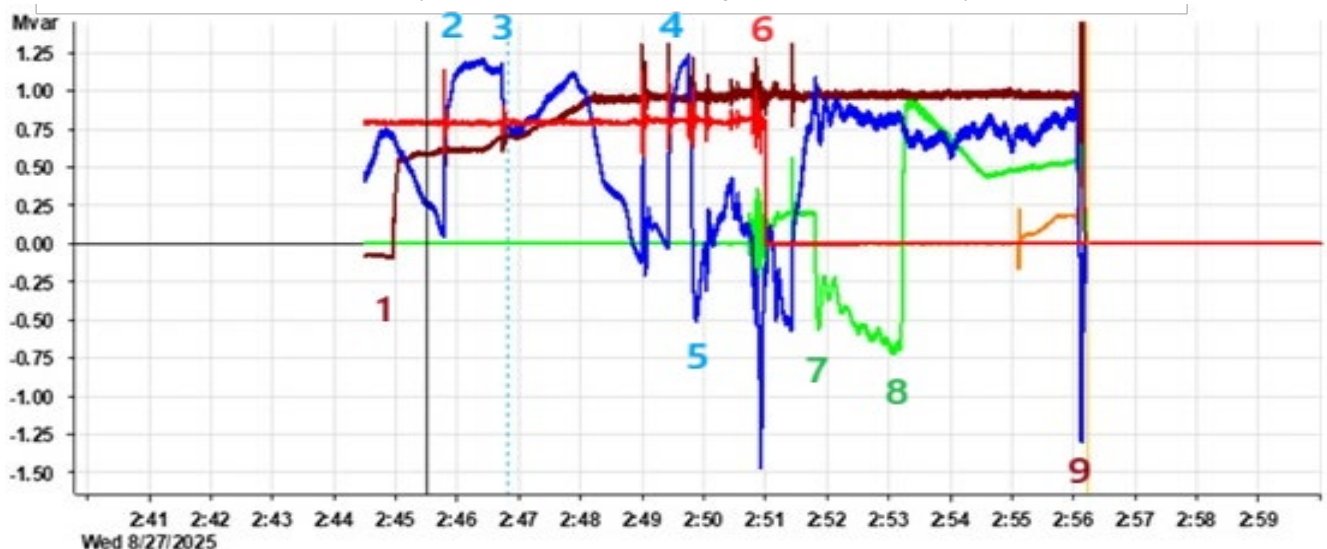
#### Active power Dokweg 1 units

- **9**: 2:56:12 trip of all 4 DKW 1 (low lubrication oil pressure, generator excitation off) units after wind farms trip
