## Security of Supply in Curaçao's Electricity System

Report on Trip Events in February 2020

Aqualectra

Digsilent GmbH, May 2020

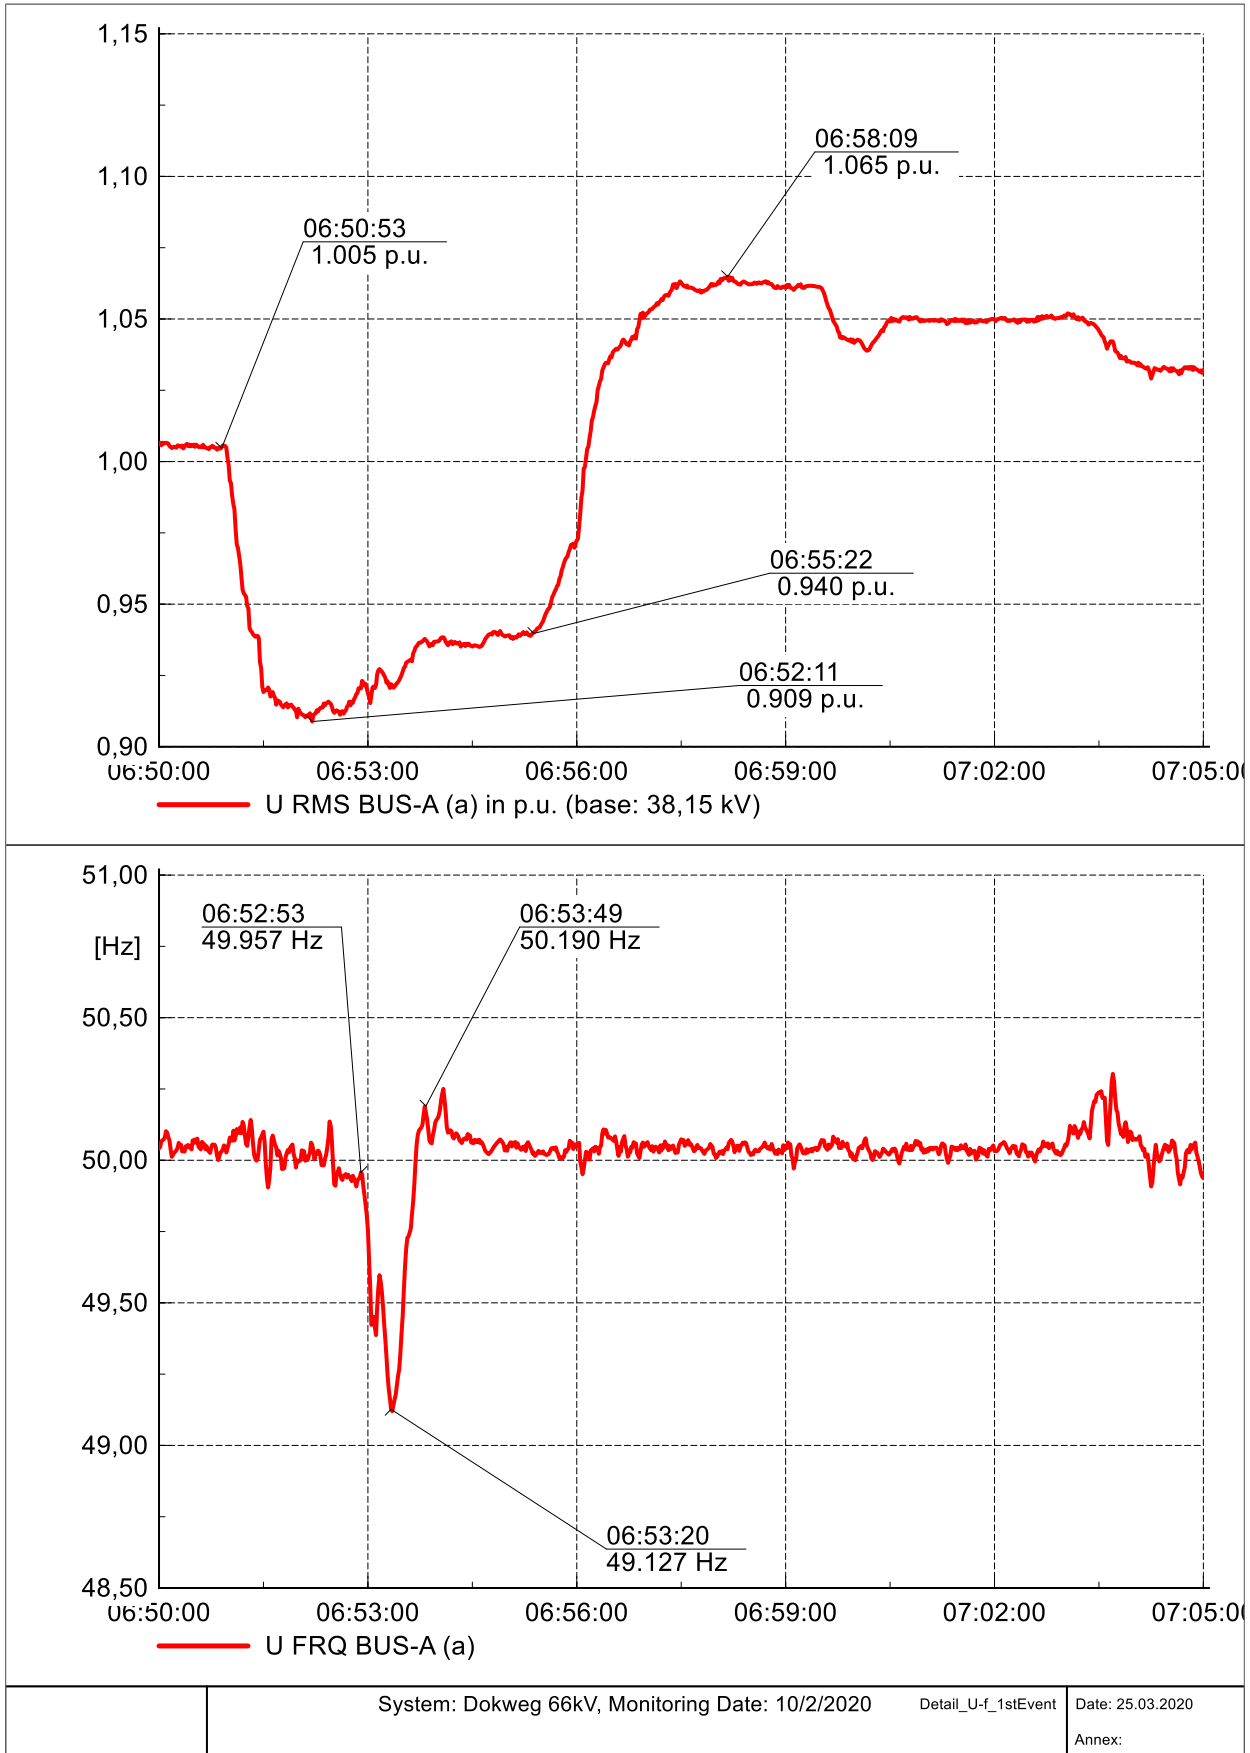
Figure 3-2: 1<sup>st</sup> event on the 10<sup>th</sup> of February 2020 – PFM Dokweg 66 kV – Voltage (up) and frequency (bottom)

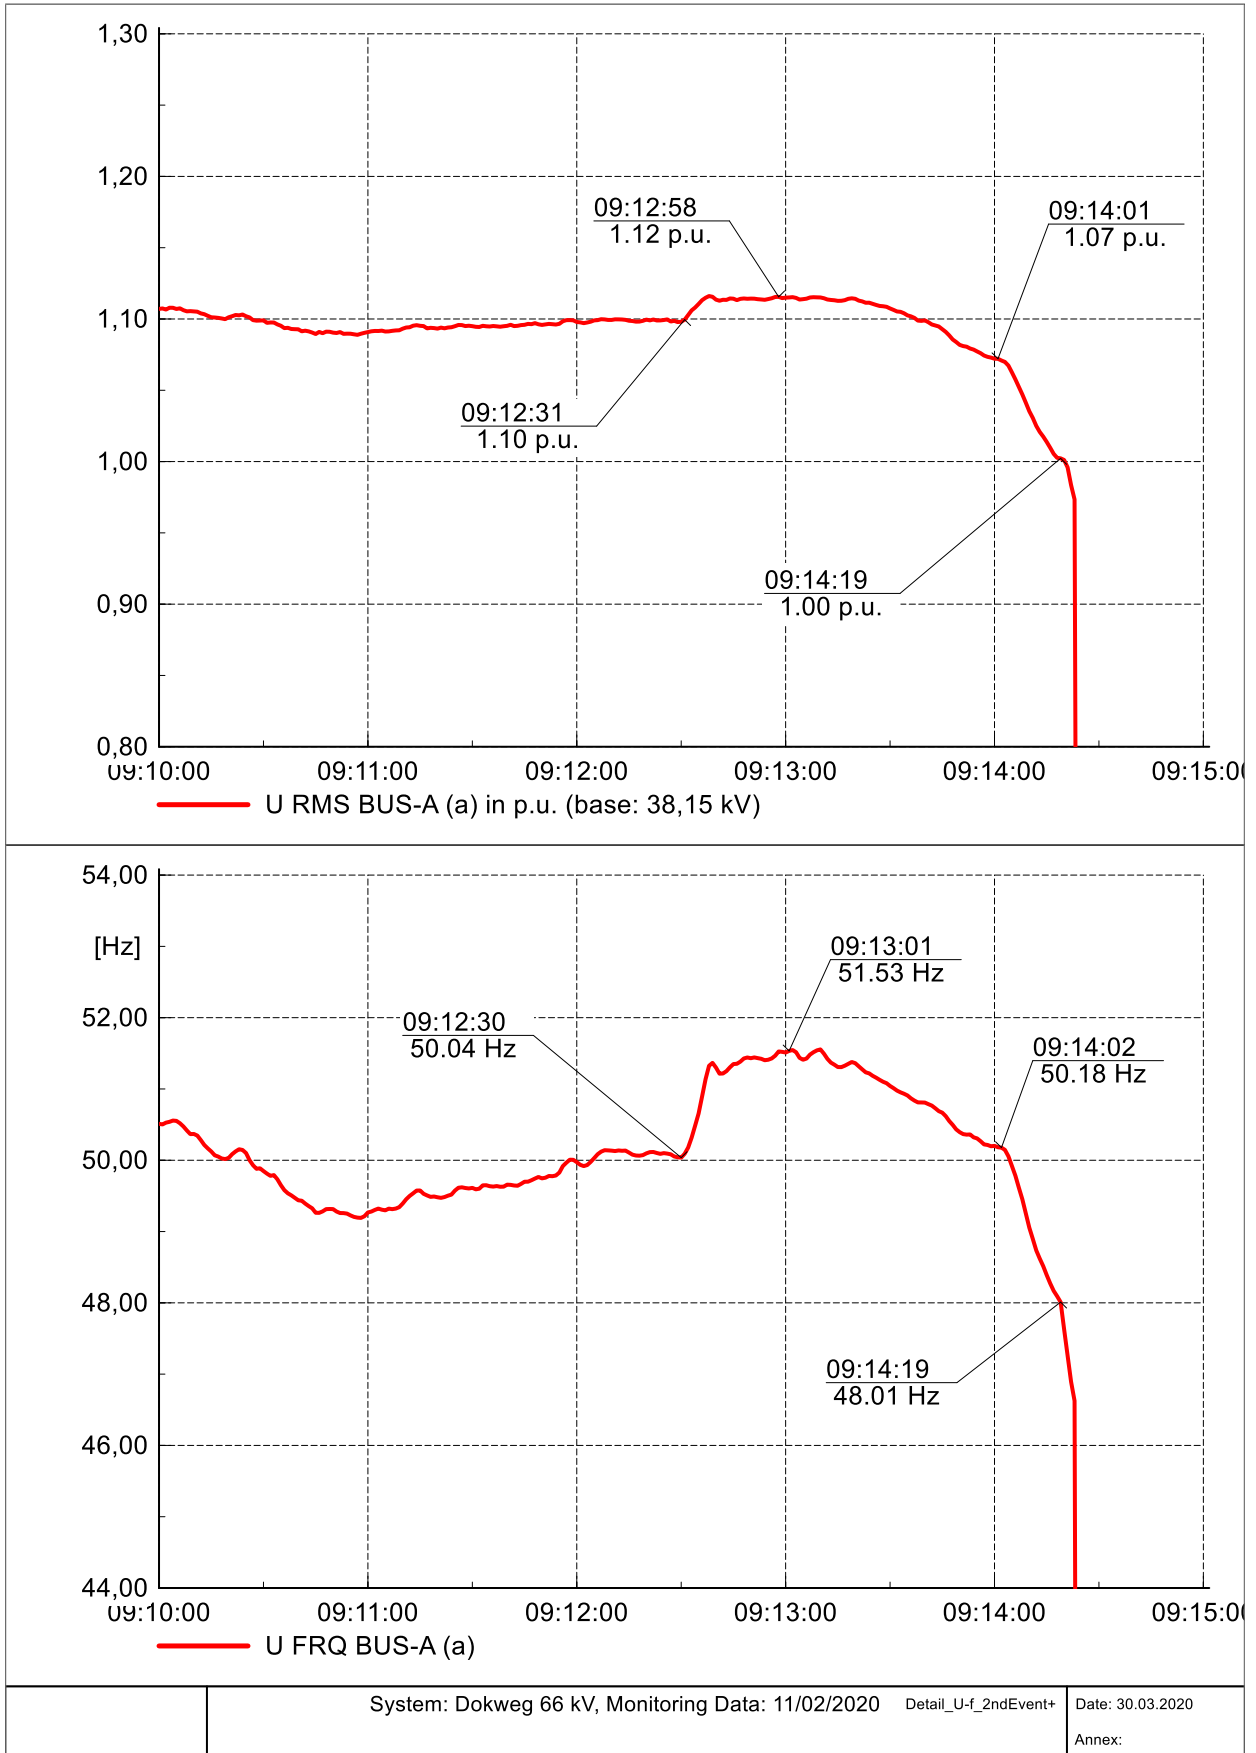
Figure 4-10: 2<sup>nd</sup> event on the 11<sup>th</sup> of February 2020 – PFM Dokweg 66 kV – Voltage (up) and frequency (bottom)

- c. The blackout seems to be initiated by overvoltage conditions (above 1,1 p.u.), sustained for more than one minute, which eventually causes the disconnection of generation that leads to a frequency decrease.
