## POWER FAILURE INVESTIGATION

# Investigation of the blackout incident Curaçao on 27 August 2025

Aqualectra

Report No.: 25-2939, Rev. 0

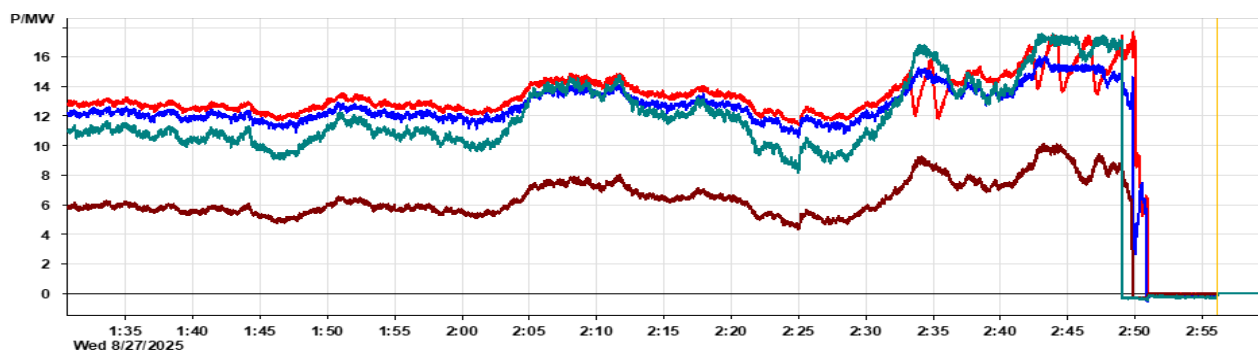
**Figure 3-12 Active power DKW 2A/2B power plants at 66 kV connection step-up transformers.** Blue: DKW 2A-T2 (DG 9/10); Green: DKW 2A-T1 (DG 11/12); Red: DKW 2B-T1 (DG 13/14); Brown DKW 2B-T2 (DG15/16)

The drop in wind power was mainly balanced by the Dokweg 2A/2B units, which were set to support the grid frequency, see Figure 3-12. This figure shows the active power output at the 66 kV connections of the 4 step-up transformers. The output increased from 42 MW at 2:30 to 59 MW at 2:43 by units DG9, 11, 12, 14, 15. Units 10,13 were in kW mode at fixed output. At Dokweg 1 increased the active power output (DG 6, while DG5 was started) while NDPP output remained unchanged because these units are operated in base load, not responding to frequency changes.

Unit DG 14 at Dokweg 2B experienced temperature issues because of the steep increase of power output at 2:33 and automatic output reduction was activated several times, see red curve in Figure 3-12. At 2:45 this unit was set to kW

operation mode by the operator to stabilize the power output. A few minutes before unit DG9 was set to kW mode by the operator because of exhaust gas temperature alarm.

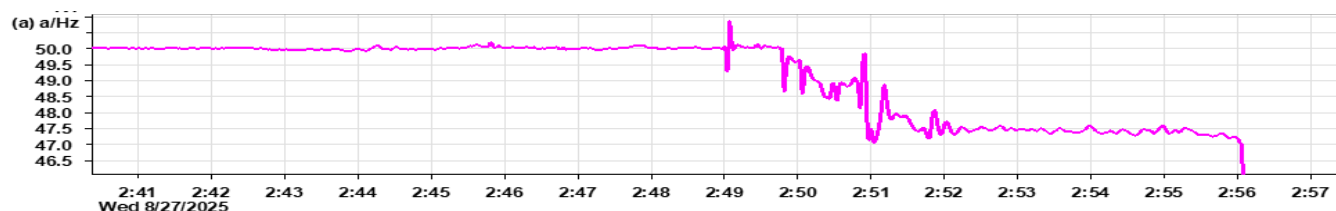
**Figure 3-16 Grid frequency**

Massive load shedding in load center Nijlweg-Weis, starting at 2:49, and power surges of the NDPP units at 2:50, see Figure 3-14, helped the power system to survive, however the frequency could not be maintained and dropped to 47.5 Hz, see Figure 3-13. When the remaining 3 wind farms tripped at 2:56 (wind farm Tera Cora 1 tripped already at 2:51), all remaining diesel generating units tripped and the system blacked out.

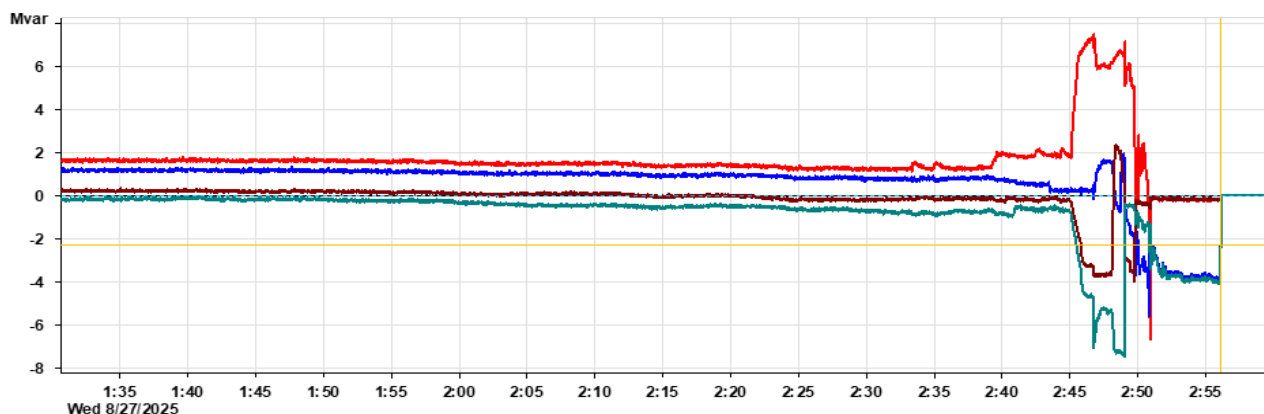
**Figure 3-17 Reactive power DKW 2A/2B power plants at 66 kV connection step-up transformers.**  
DKW 2A-T2 (DG 9/10); Green: DKW 2A-T1 (DG 11/12); Red: DKW 2B-T1 (DG 13/14); Brown DKW 2B-T2 (DG15/16)

The reactive power of the units at Dokweg 2A/2B was stable and near zero until unit DG 14 was switched to kW mode. As a consequence of this, the generator voltage control switched automatically from voltage droop mode (supporting grid voltage and reactive power balancing) to power factor control (not supporting voltage and reactive power balancing). It appeared that the internal preset power factor setpoint was at 0.85 lagging (supplying large amount of reactive power), see red curve in Figure 3-17. The units in voltage droop mode (DG 11, 12, 15), responded by absorbing this large amount of reactive power of DG 14.

The loss of reactive power absorption by these 2 units was balanced by, DG 9 and 15 at Dokweg 2A/2B, the 4 units at NDPP, see Figure 3-19, and DG 6 at Dokweg 1, see Figure 3-20. However, the 4 units at NDPP increased 45 seconds later suddenly their reactive power output because their generator voltage was automatically increased by the automatic voltage regulation on the NDPP step-up transformer. DG 15, 9, 13 responded by absorbing more reactive power and were tripped by their underexcitation protection.

Then one minute later, at 2:50:49 again a decrease of generator voltage at NDPP because of the automatic voltage regulation on the step-up transformer. The subsequent increase of reactive power supply by the 4 units at NDPP caused the two remaining units at Dokweg 2A/2B, DG 10 and 14, to trip at underexcitation.

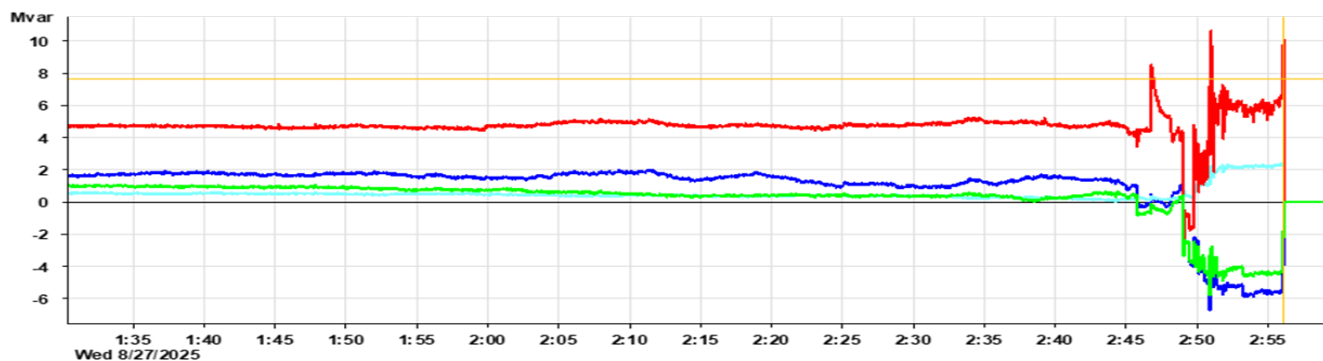
**Figure 3-19 Reactive power NDPP and net demand Nijlweg-Weis(gross demand-generation DKW 1/ wind farms)**

While Dokweg 2A/2B were struggling with the increase of reactive power of DG 14, DG 15 and DG 9

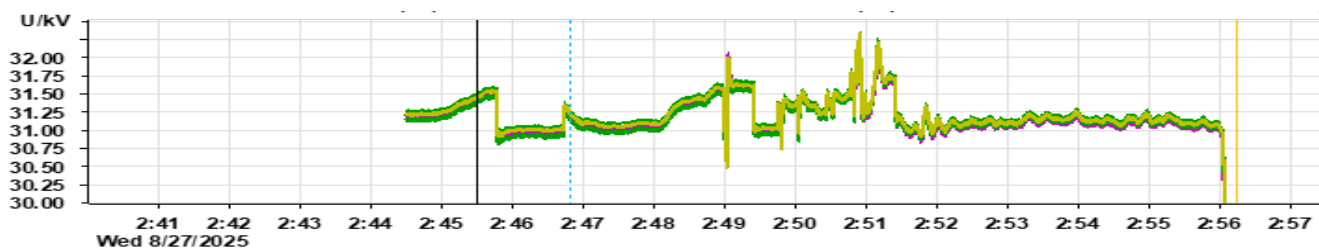
Figure 3-21 30 kV Dokweg 1 voltage recording

The reactive power output of the unit in voltage control at Dokweg 1, DG 6, was interfered by the automatic voltage regulation of the Nijlweg-Weis transformers. Because of increasing 66 kV voltage also the 30 kV voltage increased and the 30 kV automatic voltage control instructed a tap change of the Nijlweg-Weis transformers between 2:45-2:46, between 2:49-2:50 and between 2:51-2:52, see Figure 3-21. This disruption by the automatic tap changing made the voltage support by the Dokweg 1 units ineffective

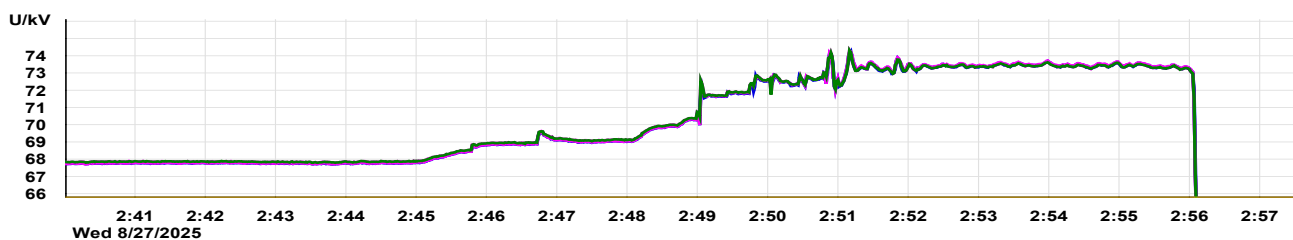
Figure 3-22 66 kV grid voltage recording

The 66 kV grid voltage increased rapidly to 74 kV after all Dokweg 2A/2B were tripped at 2:51, see Figure 3-18

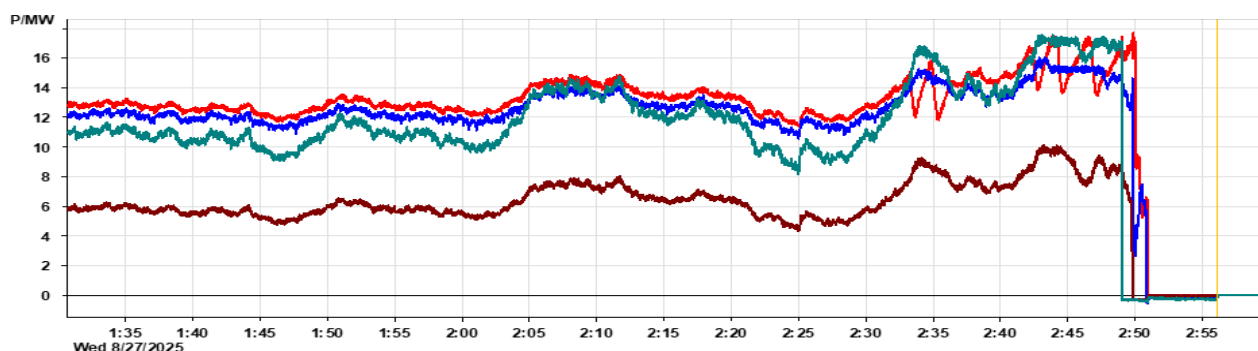
**Figure 1-1 Active power DKW 2A/2B power plants at 66 kV connection step-up transformers.** Blue: DKW 2A-T2 (DG 9/10); Green: DKW 2A-T1 (DG 11/12); Red: DKW 2B-T1 (DG 13/14); Brown DKW 2B-T2 (DG15/16)

- At 2:43 most units are near or on maximum output with very small margin for spinning reserve. However no load shedding until DG 11/12 trip at 2:49.
- 2:50:58: DKW 2B step-up and auxiliary transformers trip on overvoltage

- 2:50:59: DKW 2A step-up and auxiliary transformers trip on underfrequency

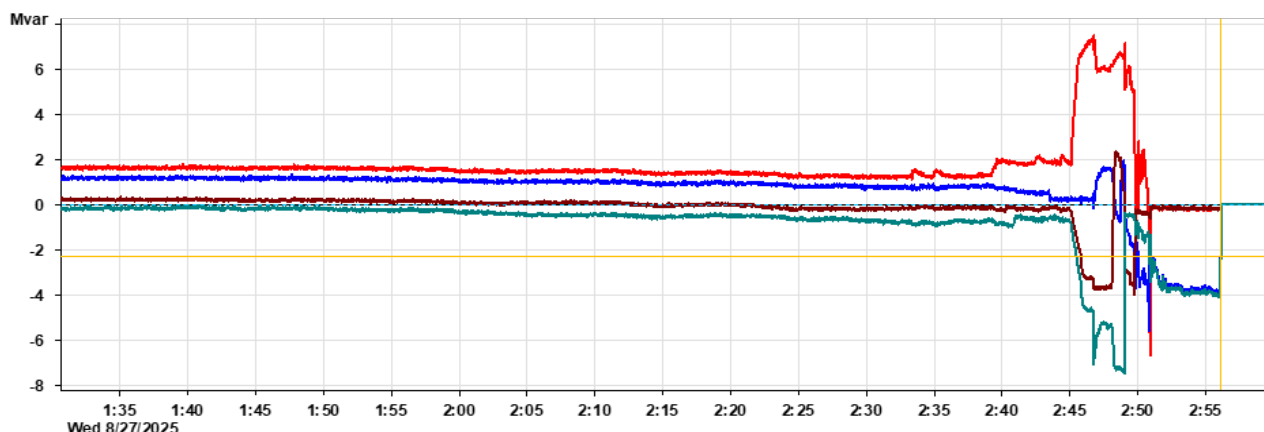
#### Reactive power DKW 2A/2B power plants at 66 kV connection step-up transformers

- At 2:51 trip of DG 10, 14 on under excitation because of response to balancing reactive power caused by trip DG 11, 12, 15, 9, 13 before.
- 2:50:58: DKW 2B step-up and auxiliary transformers trip on overvoltage

- 2:50:59: DKW 2A step-up and auxiliary transformers trip on underfrequency
- 2:49 onward: the 66 kV system voltage increases rapidly after tripping of units and load shedding

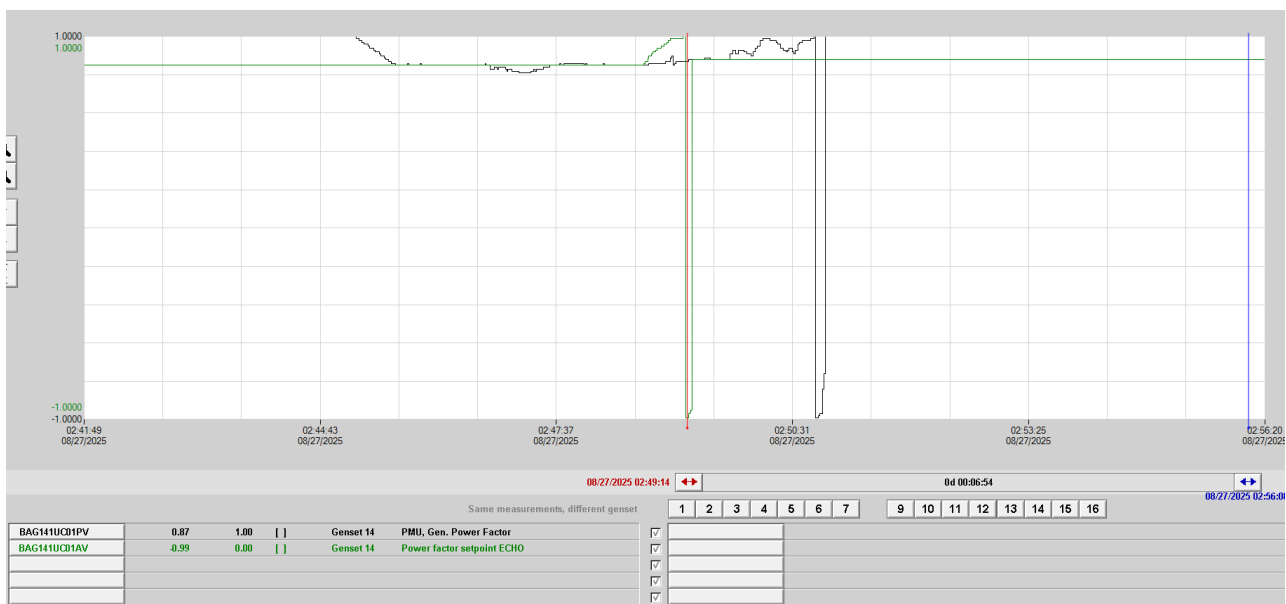
Power factor setpoint and actual power factor DG 14 (black=actual power factor, green =power factor setpoint)
